BLACKSTONE RIVER BASIN
AUBURN, MASSACHUSETTS

DARK BROOK RESERVOIR DAM

PHASE I INSPECTION REPORT
NATIONAL DAM INSPECTION PROGRAM

JULY 1980

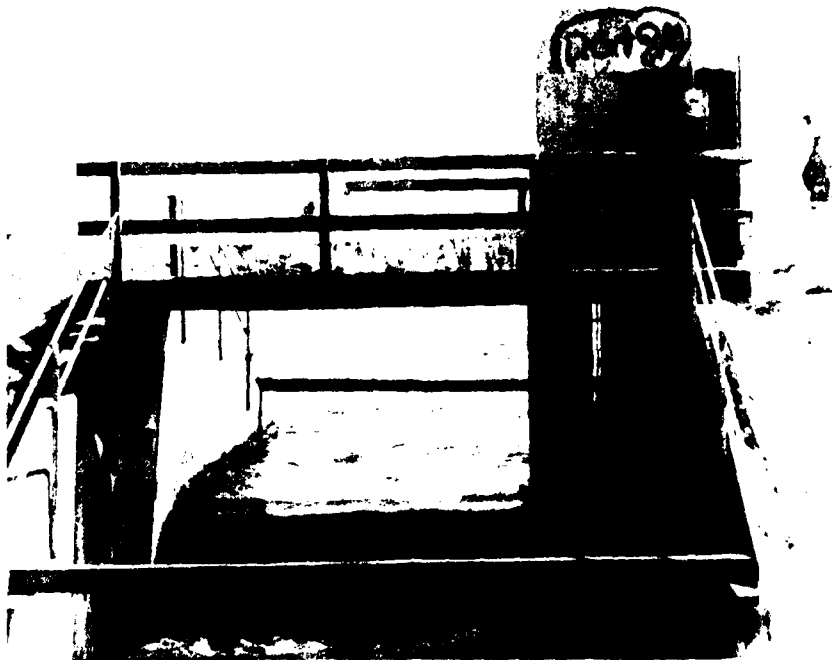
9. Spillway crest and sluice gate.

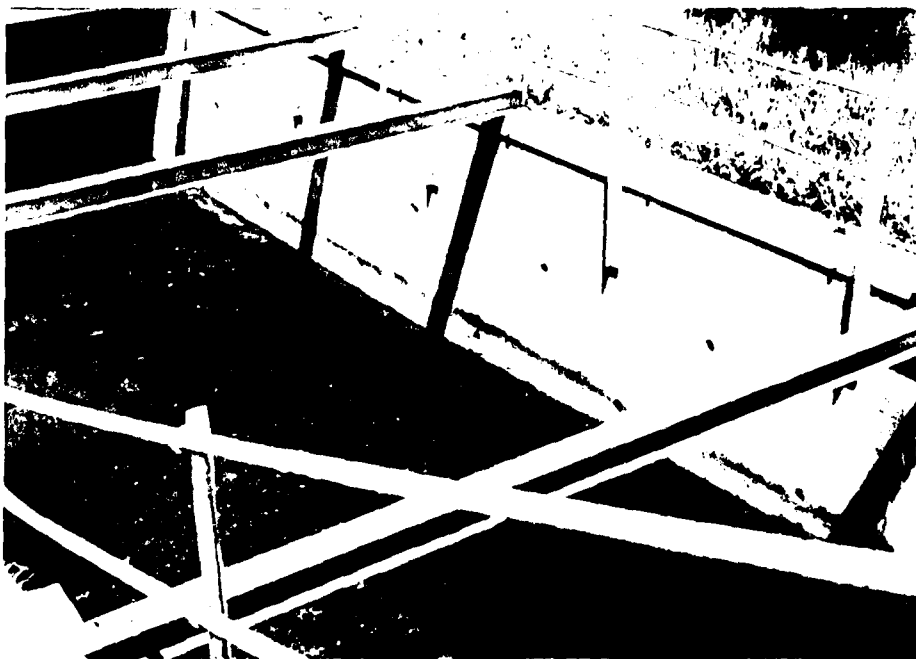
10. Right spillway training wall.

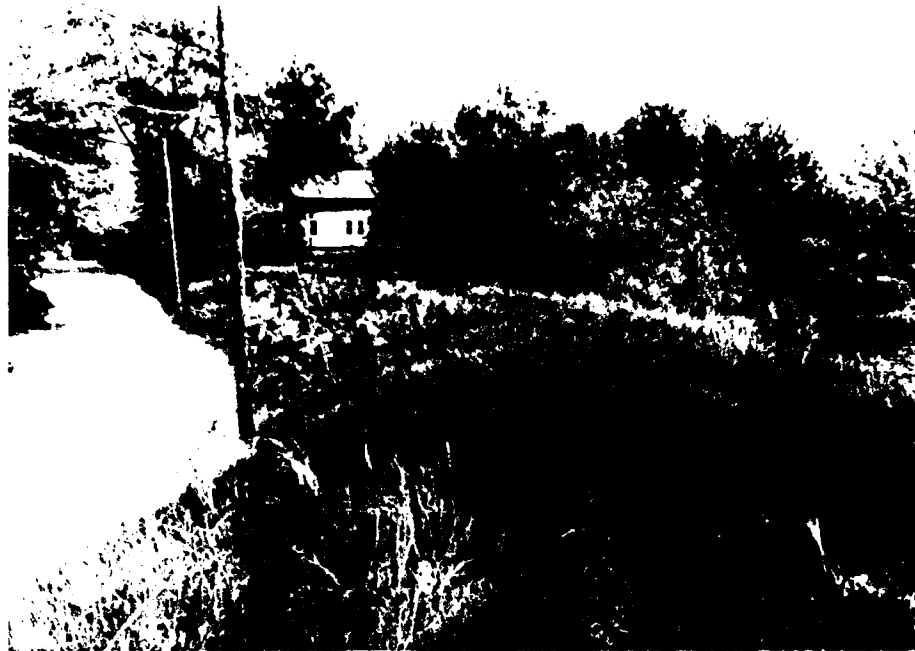
5. Crest and downstream slope of Dike A from left abutment.

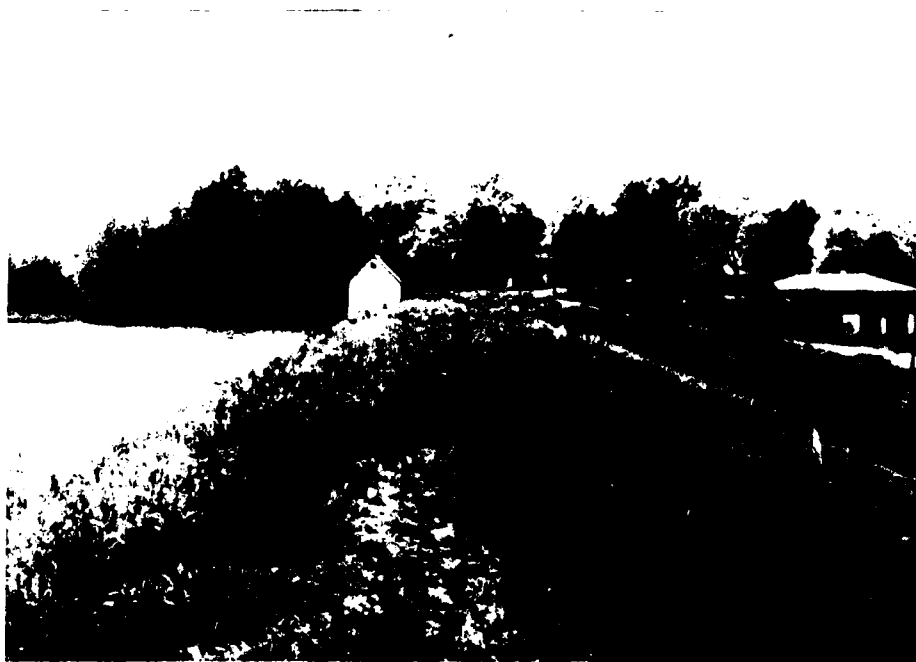
Photo No. 4 is a view of the upstream slope taken from the right abutment. The upstream slope has some minor growth generally not over 3 ft. high intermingled with the riprap on the slope. The upper 3 ft. of the slope is not riprapped but is grass covered. The riprap appears to be in good condition. It varies in size from 1 in. stones up to 4 ft. slabs. It appears that the brush on the upstream

4. Upstream slope of main dam from right abutment.
